Case Study

Birth of a Smart Sewer

Winter storm demands smart sewer in Massachusetts

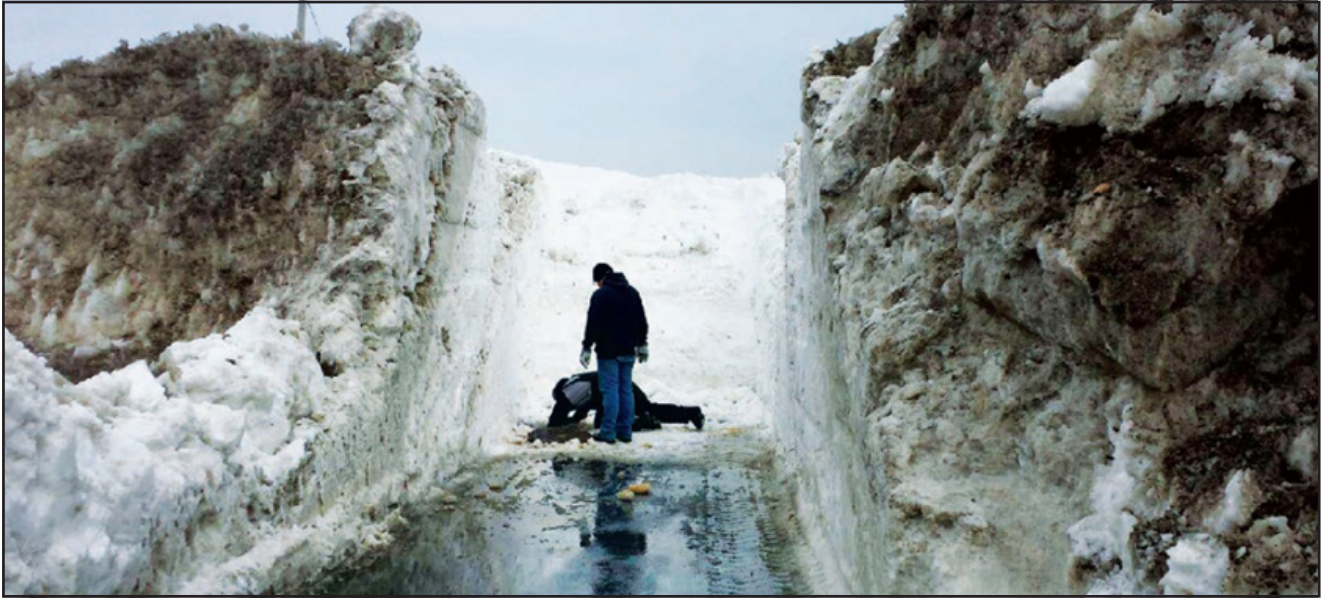
The winter storm of 2015 dumped about 110 in. of snowfall in just four weeks in the Massachusetts community of Plum Island. The storm made normal utility maintenance almost impossible.

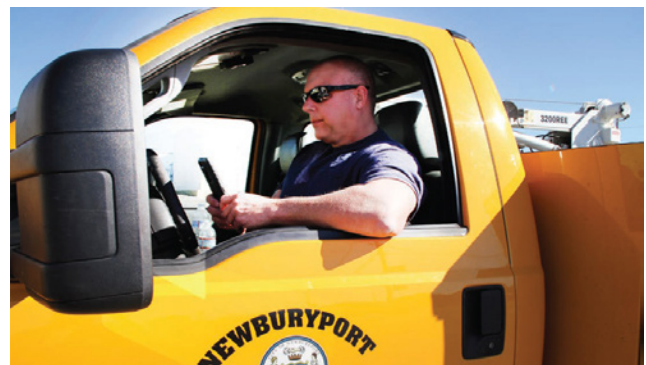
Handheld technology allows utility department personnel to access information in the field. They can address sewer problems within minutes without returning to the vacuum station to check monitoring equipment.

information to Gerald Whitten of the Merrimac Valley Planning Commission, who worked to develop a draft mobile device application. After a few revisions to the technology, a final version of the app was ready for use. We now have handheld technology that identifies the precise location of a sewer issue. There is no need to visit the central monitoring system at the vacuum station, no guesswork and no wasted time. Vacuum sewers might not be the best solution for every sewer collection application, but for a seaside community like Plum Island, they are the smart solution.
